# Characteristics and Damage Investigation of 1993 Hokkaido Nansei-oki Earthquake

Takahiro Iwatate \*, Yoshihiro Sawada \*\*, Daiei Inoue \*\*, and You Sakamoto \*\*\*

## ABSTRACT

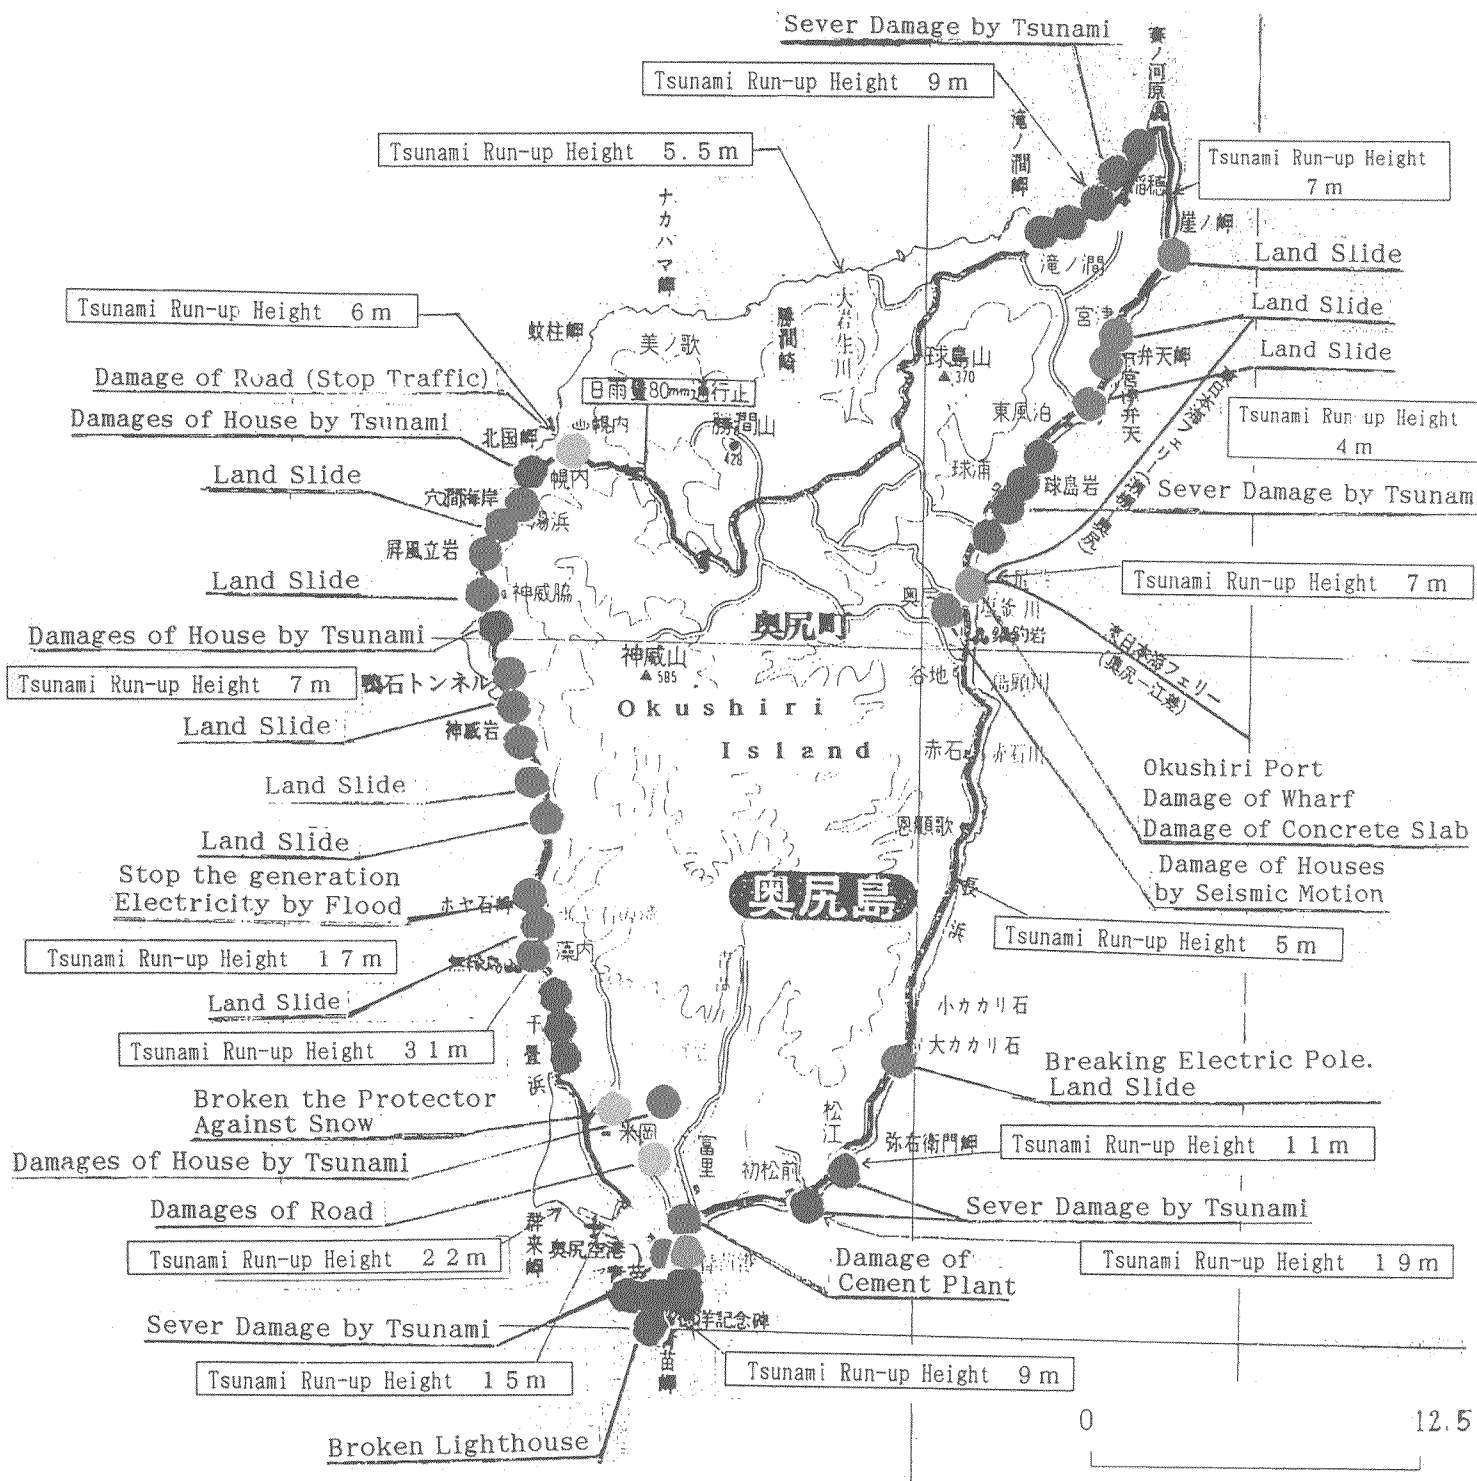
Fig. 10 Earthquake Damage of Okushiri island

Table 3 shows the summary the earthquake damages of houses, civil engineering structures compared to the other past earthquakes with same magnitude. The damages of structures of this earthquake were concentrated in the

Okushiri island and east coast of Hokkaido due to tsunami and the liquefaction of the ground. And lots of slope failure occurred in Okushiri island. The sum of the damage cost of this earthquake was about twice larger than that of Kushiro-oki earthquake, and more than two hundred people died. The main damages show as follows.
