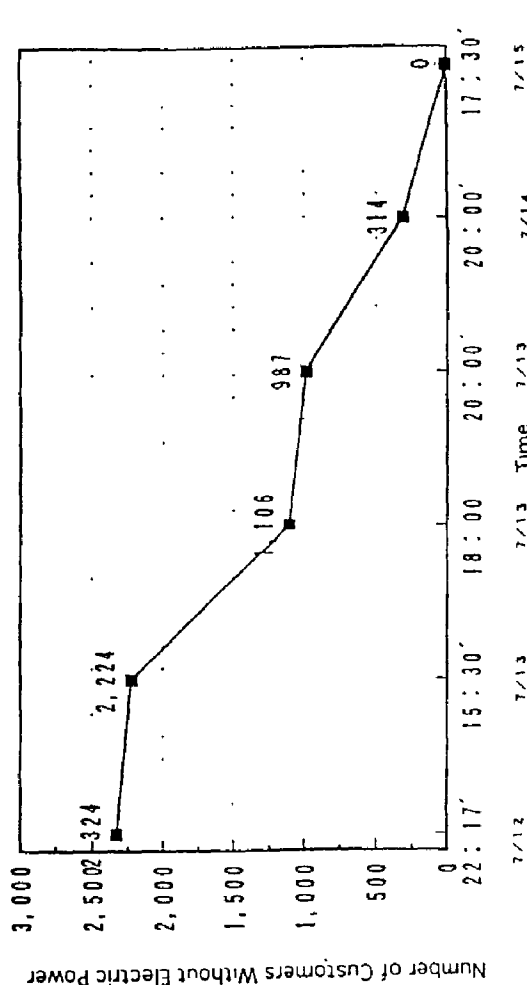
Fig. 12 The Number of Customers in Okushiri island

affected by the Earthquake

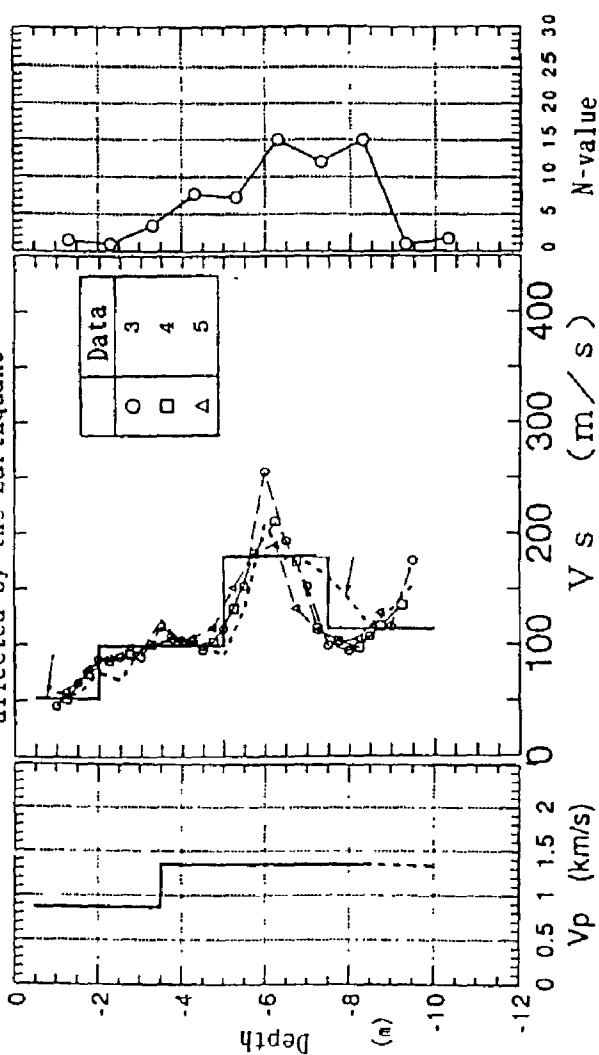
Fig. 14 Distributions of P-wave and S-wave Velocities

with Depth of the Ground

N-value(Large Penetration Tests)

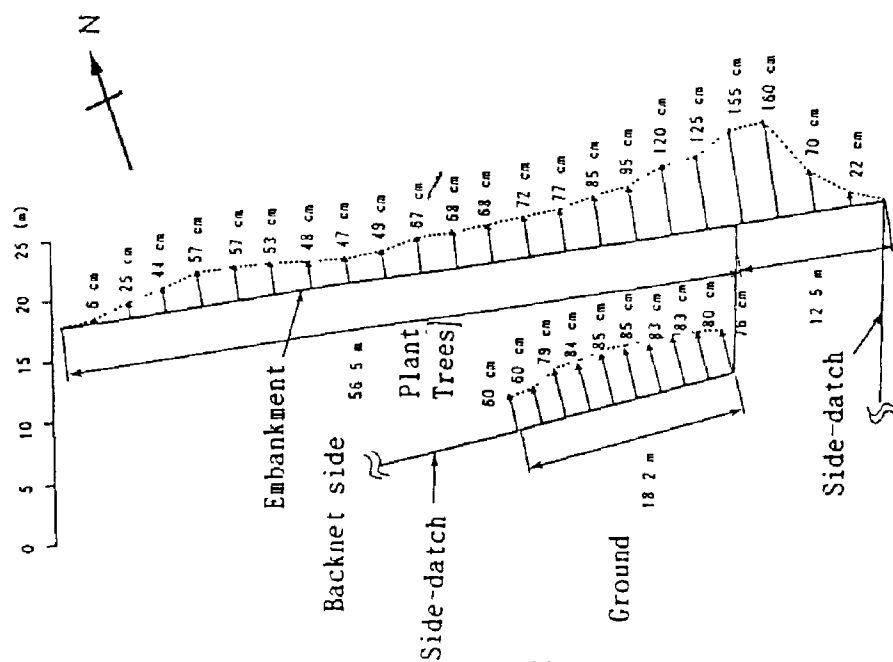
Fig. 13 Permanent Ground Displacement of

Nakanosawa Elementary School

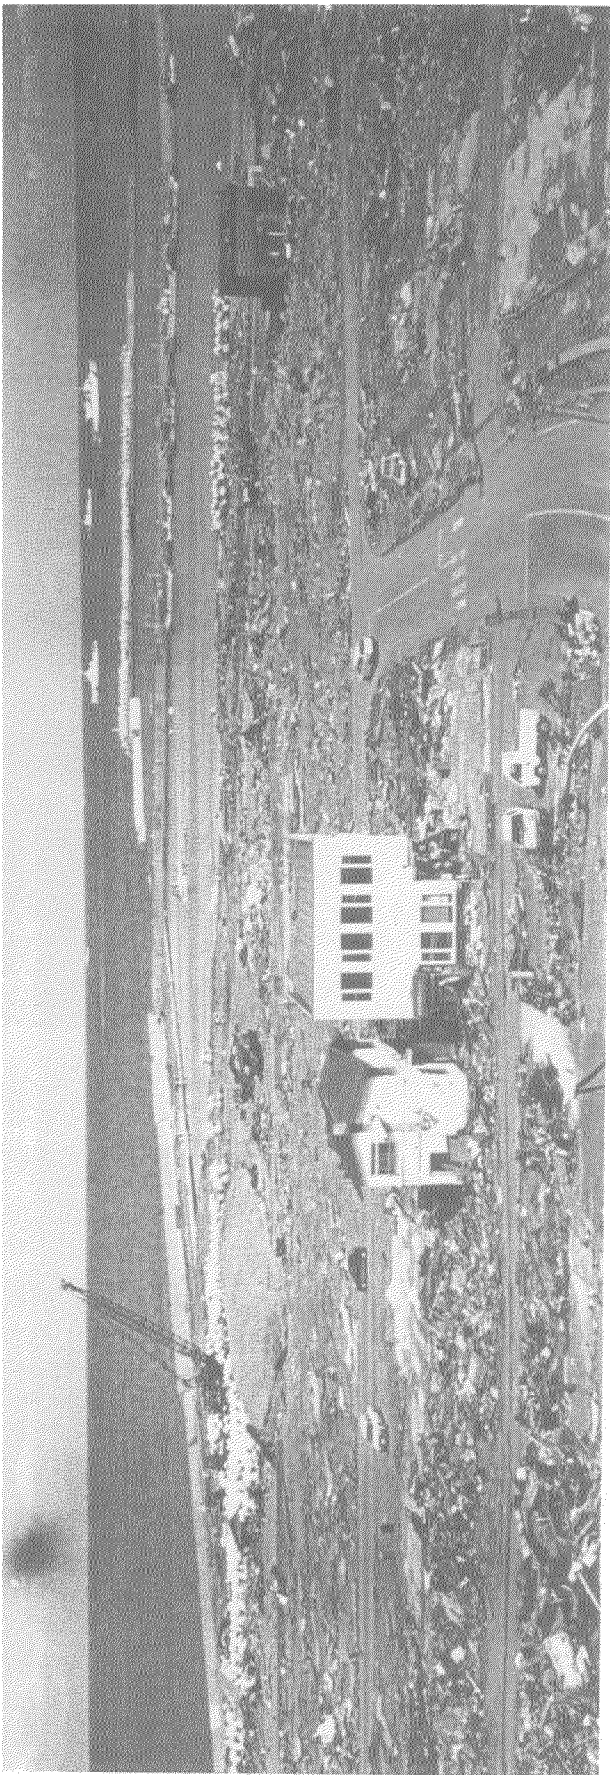
Photo 1 Overall View of the Damage of Aonae District  
(Destroyed Tunami and Fire)

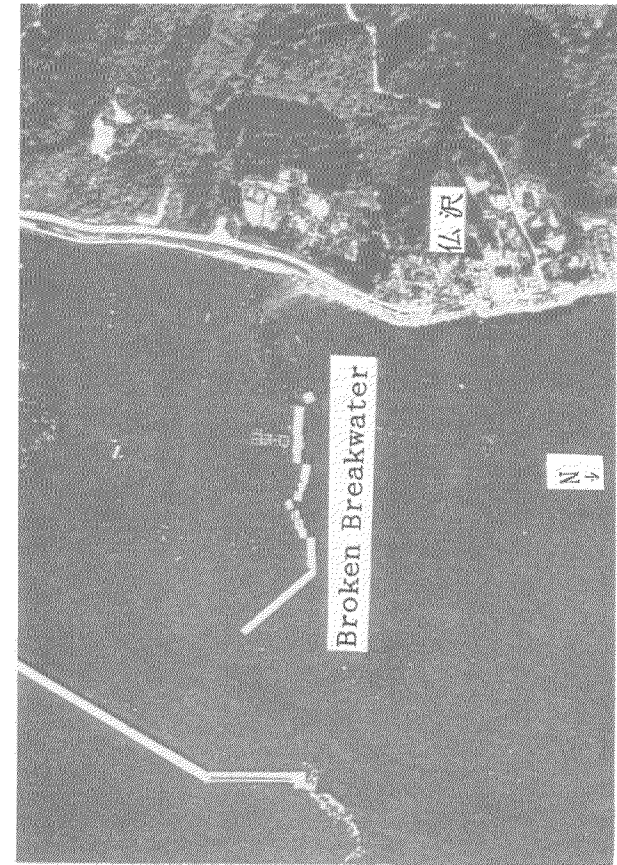
Photo 2 Broken Breakwater due to Tsunami at Okushiri island

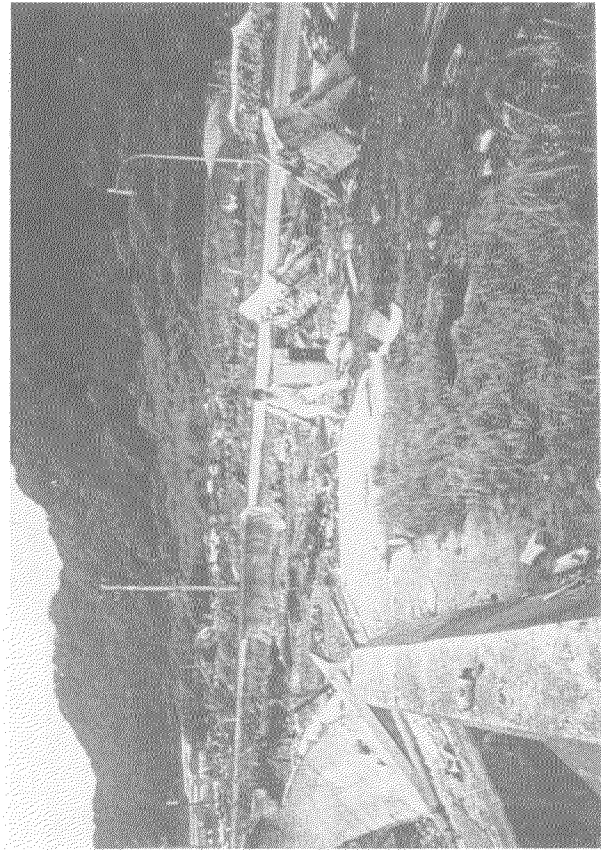
Photo 3 Broken Embankment due to Tsunami at Taisei-cho
